MPS Case Sharing

Tested Model: MP2359DJ-LF-Z

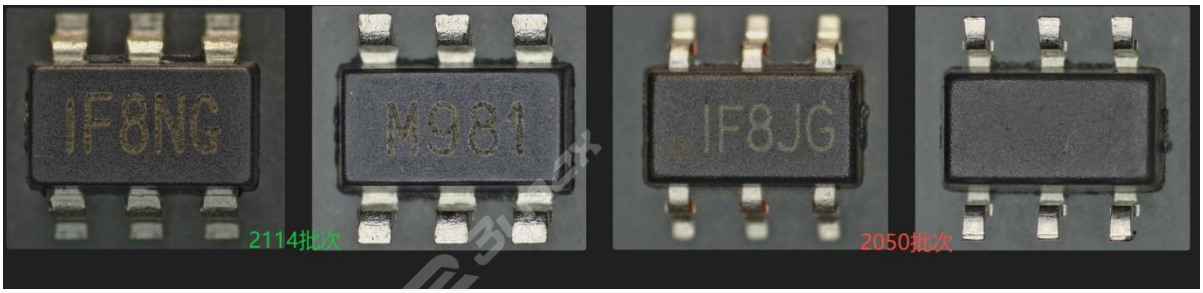
First, the outer packaging of the material was photographed. The inspection then covered batch 2114: the label, carrier tape, and the physical component were all verified and photographed. At first glance, everything appeared normal. However, upon examining the material from batch 2050, an initial impression gave the sense that the reel looked quite well-prepared. Yet, a closer look at its label raised the engineer’ s suspicion. Having just seen that the batch 2114 material was fine, a direct label comparison revealed that the batch 2050 label was indeed unusual.

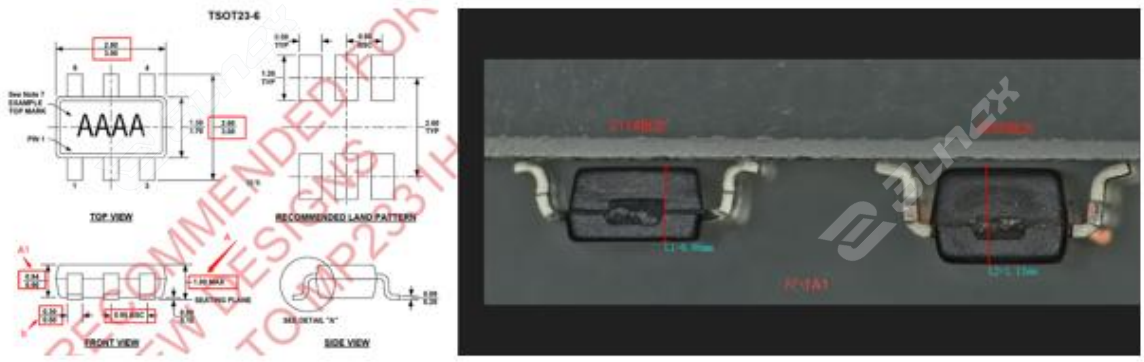
Next, dimensional comparisons were performed. The dimensions of the batch 2114 samples matched the datasheet specifications, whereas the dimensions A, A1, and b of the batch 2050 samples did not meet the datasheet requirements.

After a series of visual inspection operations, the conclusion was drawn: the batch 2114 samples are normal material, while the batch 2050 samples exhibit anomalies in both the label and the physical dimensions, identifying them as counterfeit.
